BEARING DAMAGE DUE TO ELECTRIC DISCHARGE

ELECTRICAL DISCHARGE MACHINING OF BEARINGS

Hugh Boyanton
Shaft Grounding Systems, Inc
Albany, OR

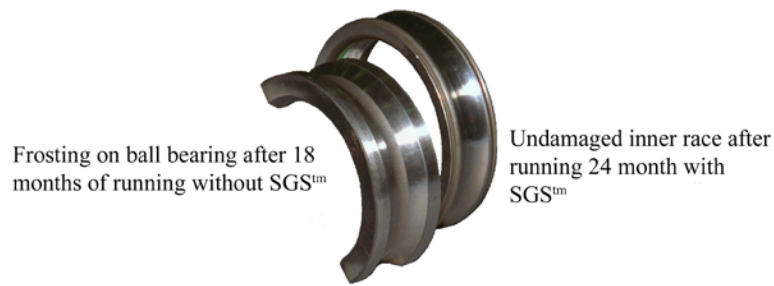
Figure 3

Examples of bearing fluting are shown in figures 1 through 3 below. Note that the flutes can have a very regular "machined" appearance. In the case of the roller bearing race shown the fluting is very narrow and closely spaced. The fluting pattern is often seen in association with continuous manufacturing processes that are operated at one speed for several hours at a time. Where running speeds vary widely with no predominant speed "frosting" may be seen instead of fluting. Frosting is an even wear pattern as compared to fluting.

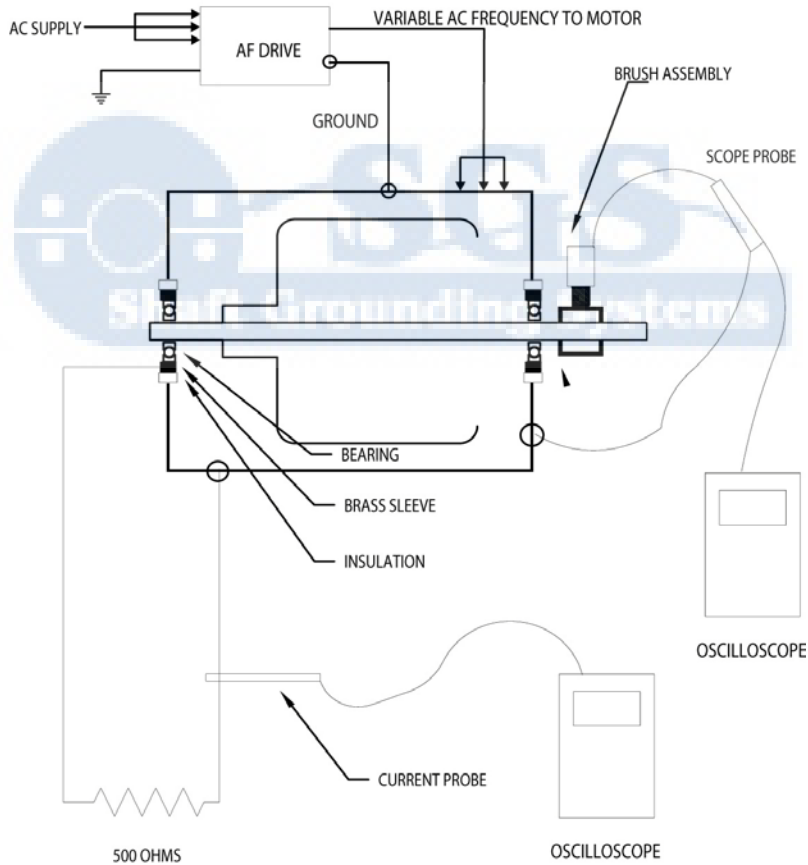
Figure 4

- a) We took a variable frequency drive and AC motor and a DC drive and DC motor and fitted them with a pick up that would allow us to measure the potential from the shaft to the frame of the motor. This was done using an insulated brush holder with a carbon brush riding on a brass sleeve

shrunk onto the motor shaft. (See figure 4 showing a sketch of the setup)
 We used a Fluke model 97 battery powered digital oscilloscope to measure the potential. This eliminated any influence from the local power supply upon the measuring equipment.

TEST ARRANGEMENT USED TO MEASURE
 SHAFT-TO-FRAME POTENTIAL AND CURRENT FLOW

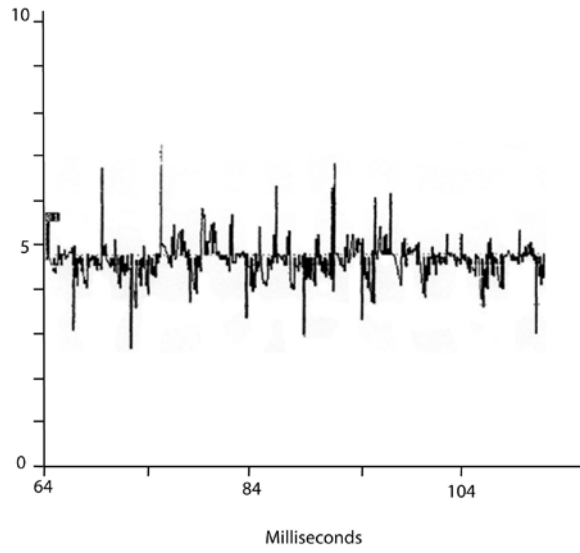
Figure 5:
Variable speed electric motor shaft-to-frame voltage

- b) The drives were first connected to a transformer that had twenty DC drives on it driving the dry end of a paper machine. We measured the shaft potential and we observed spikes as high as 70 volts on the DC motors and 30 volts on the AC motors. The occurrences were sporadic as well and the polarity of the voltage spikes was variable. (See figures 5 and 6 showing the oscilloscope traces).
- c) We next powered each drive separately from a power source that had no electric drives involved. We observed no substantial differences in the display on the oscilloscope.
- d) We moved the drives to a separate facility that had an entirely different AC power source and again we observed the same voltage readings as before.

1. The DC and AC motor bearings were insulated on both ends by machining out the end bells of the motors and pressing in a phenolic insulating material.
2. An insulated conductor was attached to the outer race of each bearing and ran to the outside of the motors. This allowed us to operate each motor with either one or both bearings insulated. It also allowed the motors to be operated with un-insulated bearings.
3. We first tested the DC motor with only one bearing insulated. We saw a slight increase in the shaft voltages with the same sporadic spikes similar to figure 5.

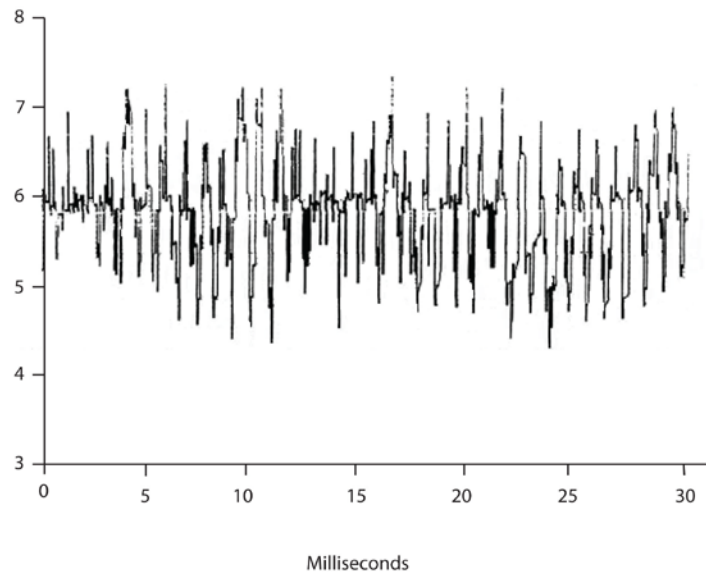
Figure 6

Shaft-to-Frame Voltage at 5volts/division

AC variable speed drive

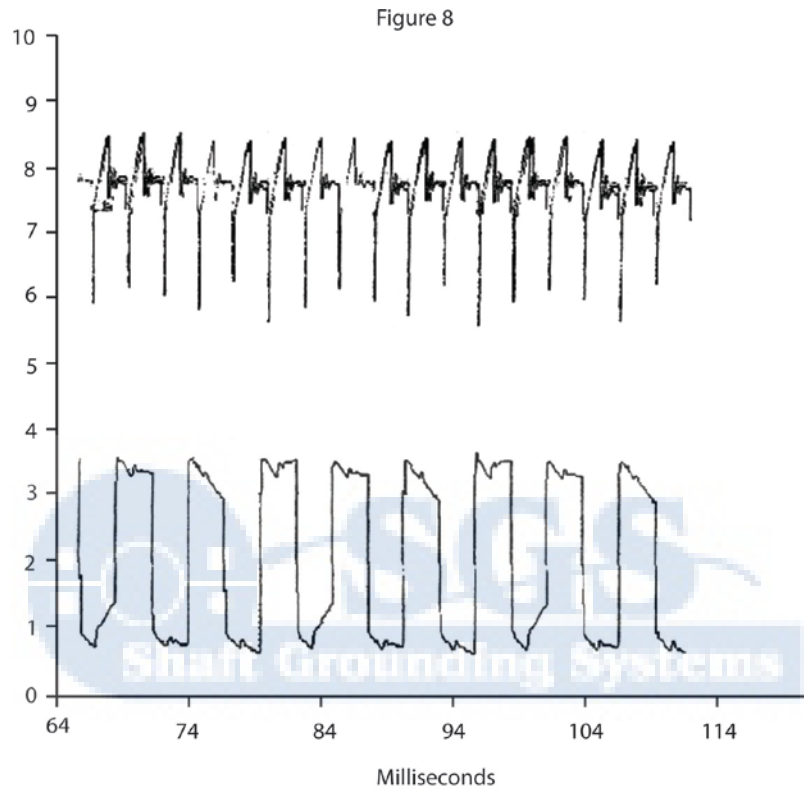
Each time an SCR would turn on we would see the polarity change on the shaft-to-frame potential.

DC shaft-to-frame voltage: Insulated bearing with
SCR firing

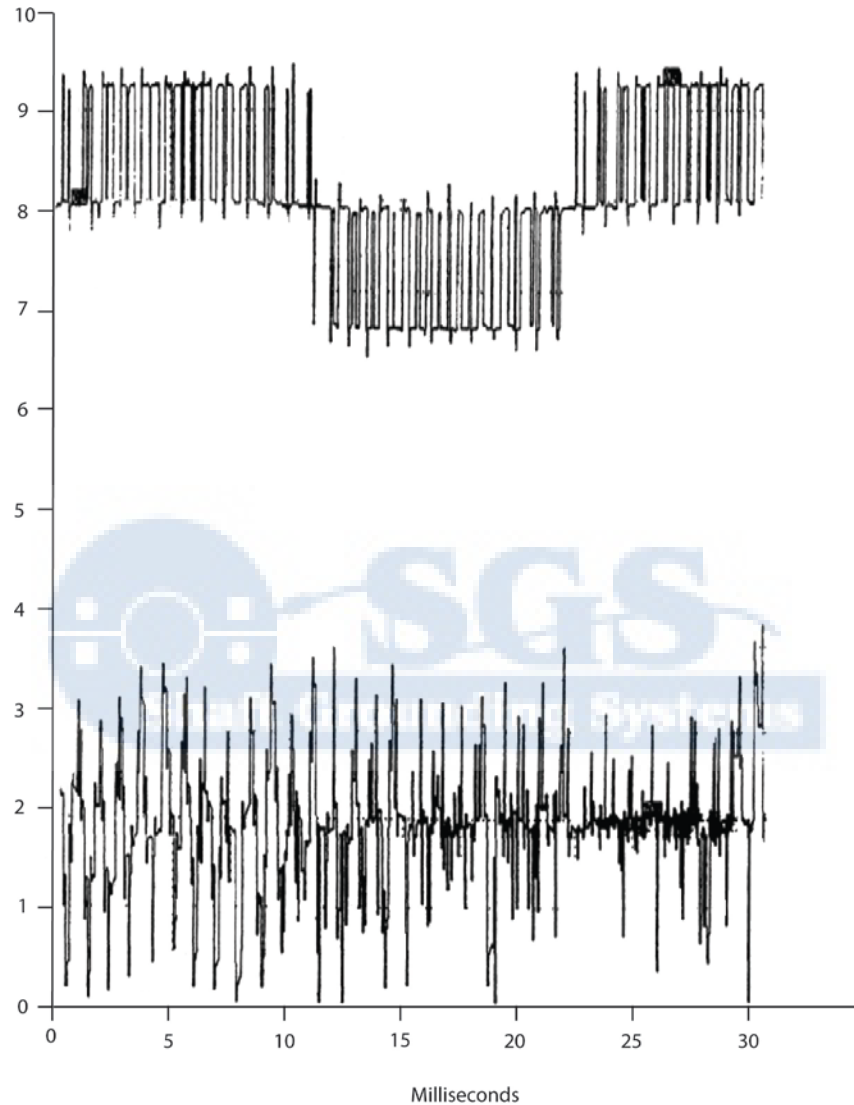
Figure 9

6. Next, we repeated these tests using the AC variable frequency drive and motor. The voltages were not as high but frequency of the voltage spikes was found to be much higher (see figure 9). It was apparent that each time a drive system transistor would turn on or off the effect could be seen as a shift in the shaft to frame potential.

AC shaft-to-frame voltage and VFD wave

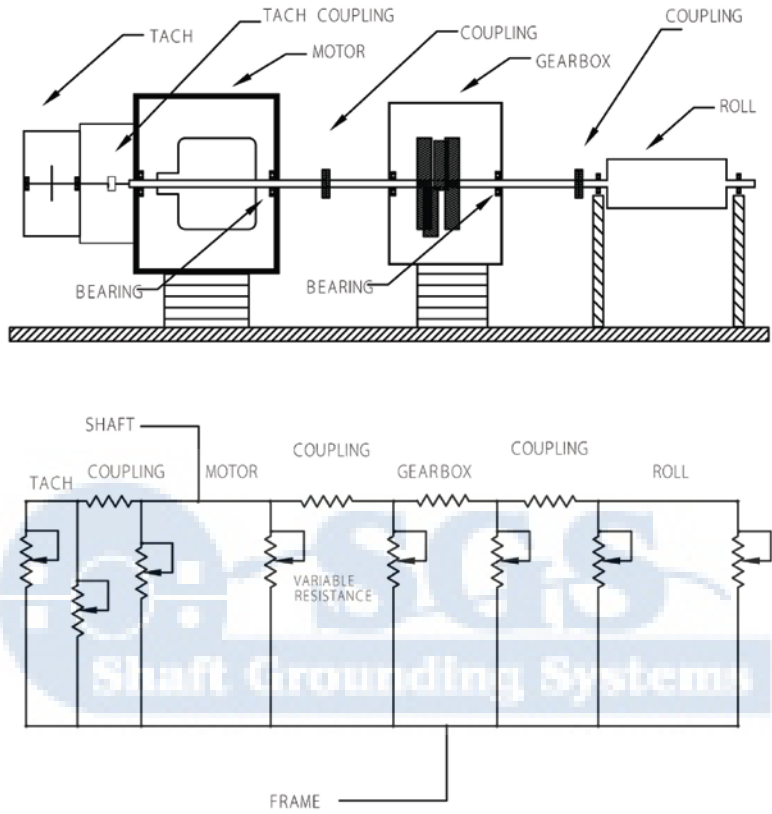
Figure 10

1. We tested both units and found that insulating just one end of the motor would actually cause the rate of ED bearing damage to happen more quickly in the un-insulated bearing.
2. We also determined that if there was a discharge path available in the motor or connected equipment and potential on the shaft rose beyond a certain level the dielectric strength of the lubricant would be overcome and current would flow (see figure 10).
3. In trying to identify the "break-over" voltage of the lubricant we set up a test using a Variac power supply (a variable AC power supply). We took a mild steel shaft and installed two bearings, one on each end of the shaft. The shaft was driven with an 1800 rpm motor through an insulated coupling.

Machinery bearing train and electrical equivalent showing multiple electrical pathways from shaft-to-frame to bearings

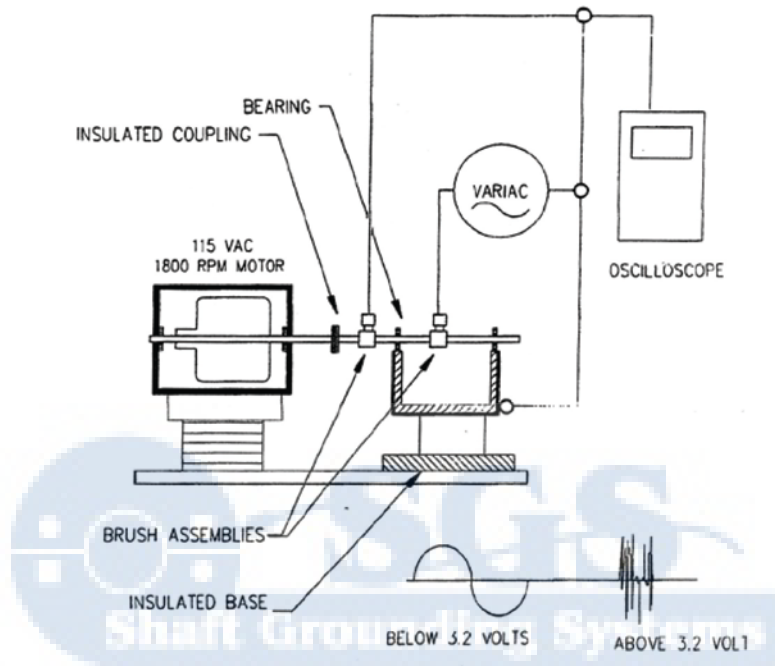
Figure 11

We also installed two insulated electrical brush holders, one at each end of the shaft. One of the brush holder we connected on one side of the variable AC power source and connected the other side to the bearing housings.

The fluke oscilloscope was connected to the other brush holder and the ground was connected to the two bearing housings (see figure 11).

When the voltage on the shaft was below 3.2 volts we would see a 60 Hz sinusoidal wave form. When the potential on the shaft exceeded 3.2 volts we would see an erratic looking signal on the oscilloscope suggesting current had begun to flow. When the voltage was lowered below 3.2 volts the 60 Hz sinusoidal wave form would return.

Test unit to determine break-over voltage
 where current will flow through bearing

Our conclusion is that the break-over voltage is dependent upon the thickness of the film of lubricant and the other motor running conditions such as temperature.

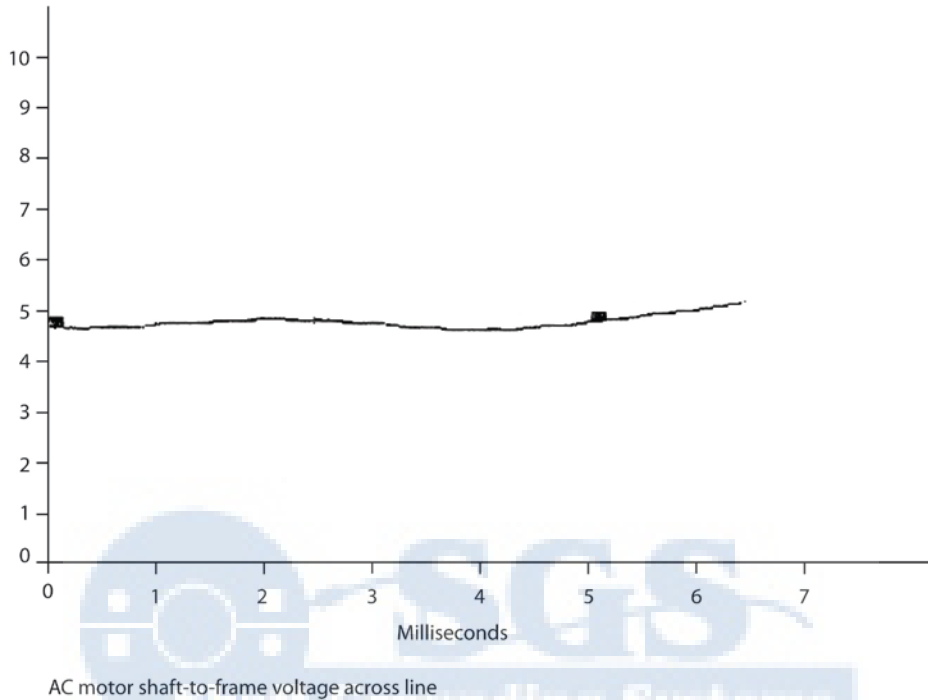
Figure 12

The shaft-to-frame potential on a conventional (non adjustable frequency) AC motor was tested. This data was taken with the motor running "across the line" (not running on a variable frequency drive). Voltage levels ranging from 0.1 volt to 2 volts were measured. The voltage seemed to vary this amount from motor to motor. As long as there was not any current flow there was no damage to the bearings (see figure 12).
